Seismic damage analysis of the morisada building, SSRC Annual Meeting Proceedings, 1984. M.S. thesis

SEISMIC DAMAGE ANALYSIS OF THE MORISADA BUILDING

Le-Wu Lu¹ and Shiunn-Jang Wang²Introduction

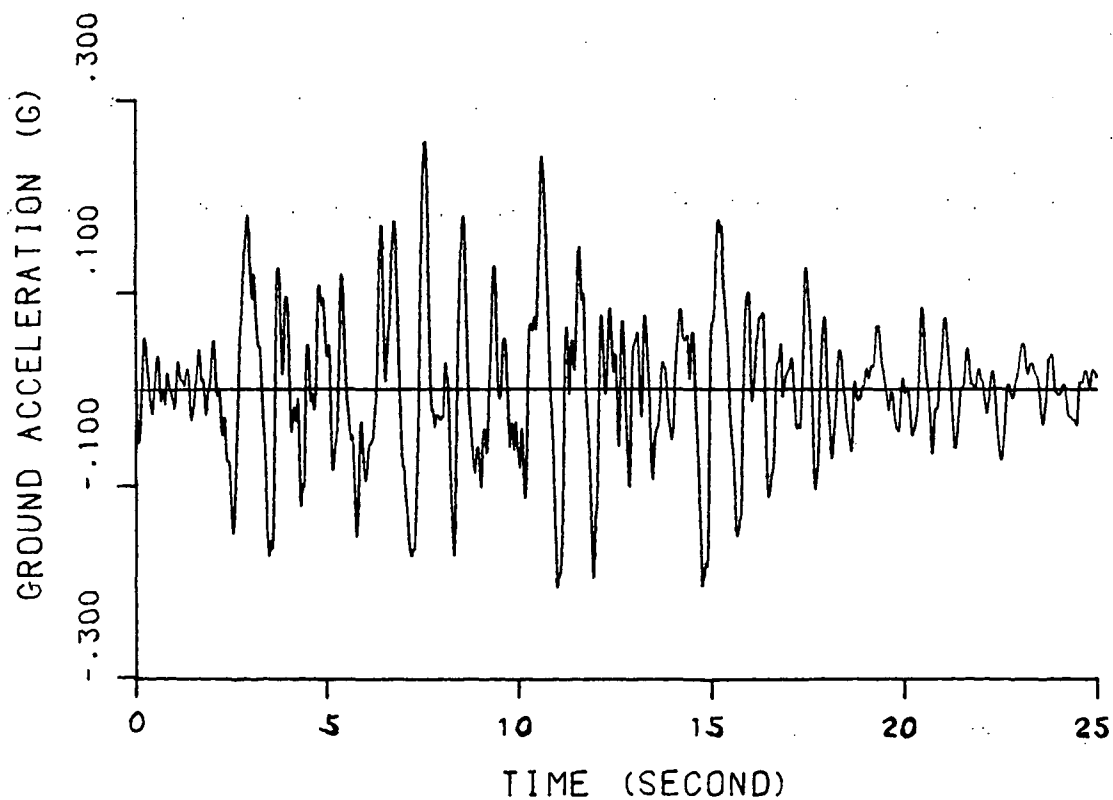
Fig. 4 Ground Motion Record Used in Study

Time-history analyses of the building have been performed using the accelerations recorded on the first floor of the Architecture and Civil Engineering Building of the Tohoku University. The university is located on a hill, 7km away. The N-S component of the record with a peak acceleration of 258 gals. (Fig. 4) has been used in the analysis. The response spectrum of the record is given in Fig. 5, which shows a peak at about one second, very close to the natural period of the structure.

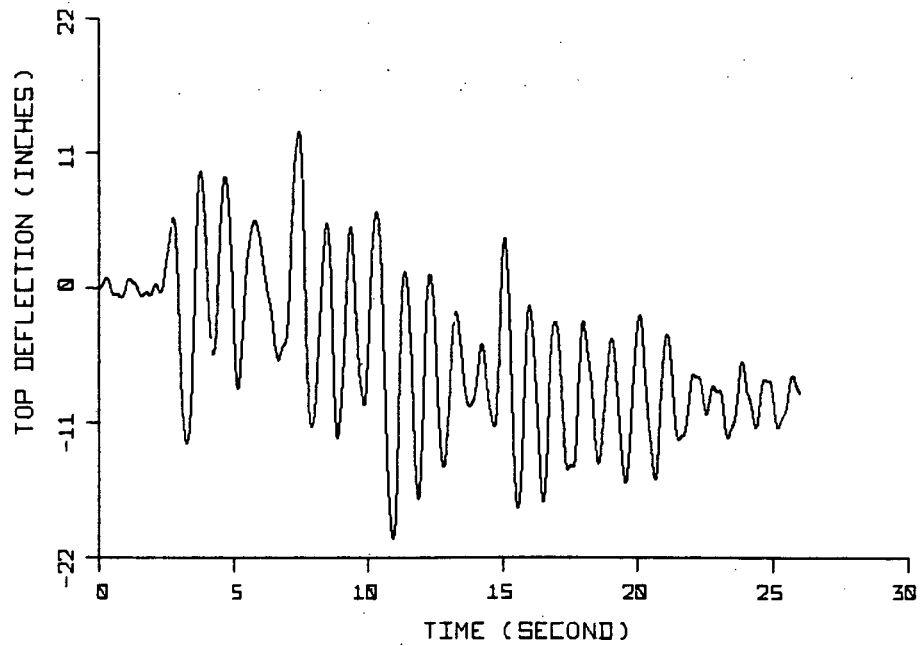
Fig. 6 Response History of Roof Deflection

The DRAIN-2D program is used to perform most of the calculations. The concepts and features of the program are described in Ref. 6. The structure is idealized as a planar assemblage of discrete elements and the analysis is done by the Direct Stiffness Method with the nodal displacements as the unknowns. First-order analysis, in which the effect of P- Δ moment is ignored, has been performed for a mass-proportional damping equal to 5% of the critical damping of the first mode. Different strain-hardening properties have been selected and incorporated into the analysis. Figure 6 shows the roof deflection vs. time relationship of the building for a strain-hardening modulus of 0.0074E (E = Young's modulus) and allowing a 21% increase of the plastic moment of the columns. These values were recommended by Kabe and Rea based on some shaking table tests of small-scale steel frames (7). The maximum roof deflection has been found to be 20.4cm with a permanent deflection of 9.3cm. The latter figure is to be compared with the 13cm column deflection mentioned before. A later analysis using a computer program developed by Professor F. Y. Cheng at the University of Missouri-Rolla and taking into account the P- Δ effect shows a considerably larger permanent deflection. This indicates that a significant portion of the permanent deflection may be due to the P- Δ effect.
